A Proposed Highly Damped Repair for the Aft Fuselage of the F/A-18

DSTO-TR-1374

Air Vehicles Division
Platforms Sciences Laboratory

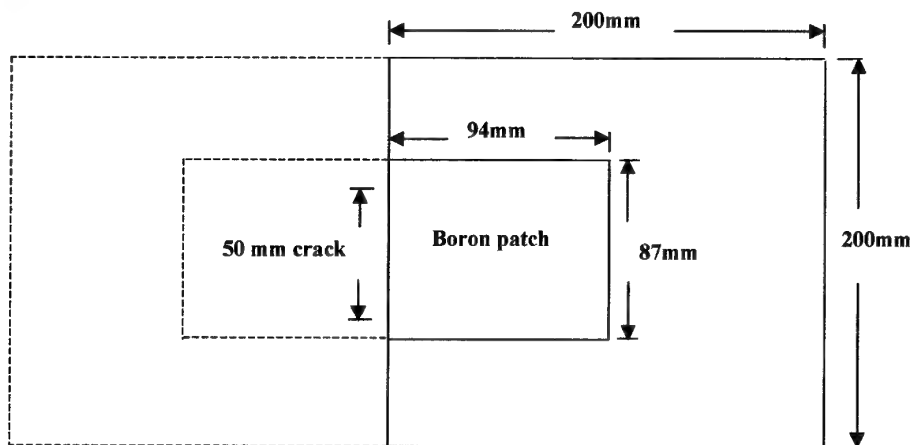
Figure 4. Dimensions of repair, plan view

In order to study the cracking mechanisms of the cracked and repaired/cracked aft skin cases, a simplified model has been developed in which the skin is considered to be a flat rectangle. Most of the skin panels in which cracking occurs have a chemical milled step in which the panel is reduced in thickness to 0.91mm. While the width and height dimensions of each panel vary, the F.E. model has representative dimensions as shown in Fig. 4. Also shown in Fig. 4 the local uni-directional patch extends partially across the panel, but since the crack lies near the boundary the repair will continue across the adjacent panel as shown in the dotted outline. In order to accurately represent the bending of the panel, 2 layers 20 noded brick elements have been used through the thickness. The F.E. mesh is shown in Fig. 5. The local boron/epoxy repair [O₃] has been applied to make up for material lost as a result of the crack. The highly damped section of the repair covers the entire panel including the local boron patch. This section consists of two viscoelastic layers with two boron/epoxy [0/90] constraining layers as shown in Fig. 6. The viscoelastic layers and adhesive have been modelled using 3D elements as are the constraining layers. The total structure consists of 7000, 20 noded brick, elements and 29000 nodes.

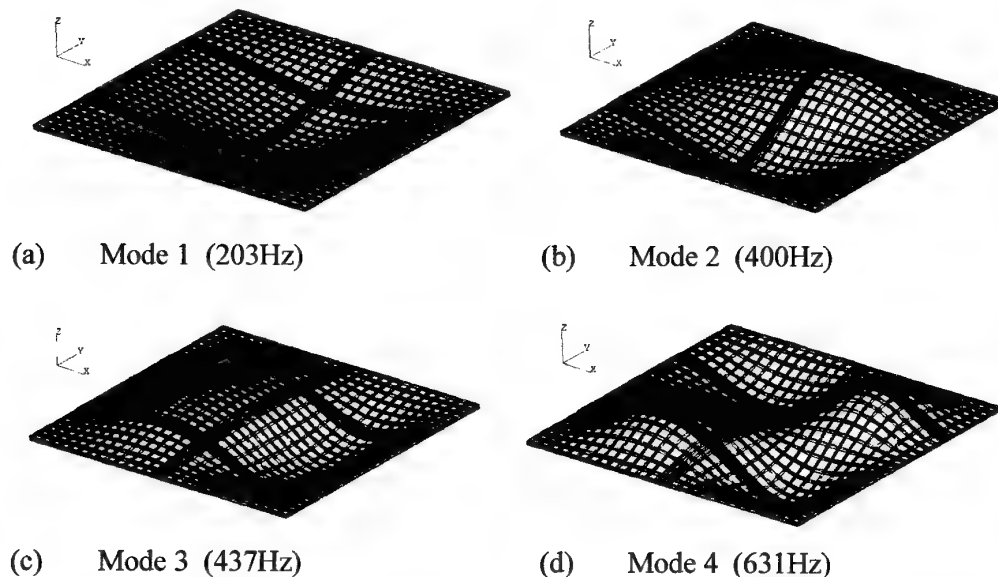
Figure 7. Modes and frequencies for repaired plate

A modal analysis has been carried out using NASTRAN program, [11], to determine the mode shapes and frequencies. The first four mode shapes are shown below in Fig. 7. The PSD of the response is plotted in Fig. 8 From this curve it is clear that mode 1 provides the greatest contribution to the response at a frequency of 203Hz. The mean square contribution of the other modes is more than one order of magnitude smaller than that for mode 1.

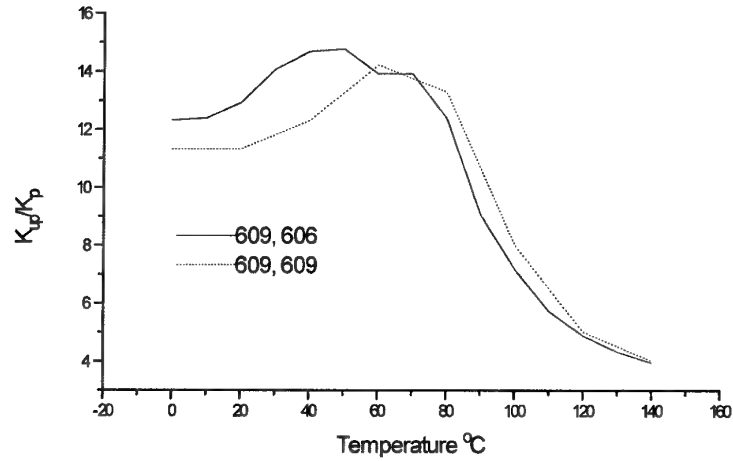
Figure 15. Plot of K_u/K_p versus temperature for configurations using 609 and 606.

In Fig. 15 a plot is shown of the variation in the ratio of stress intensity factor, for the cracked unpatched plate (K_{up}) to the stress intensity of the repaired plate (K_p), with increasing operating temperature for a patch incorporating both 606 and 609 (viscoelastic material) VEM and two layers of Dyad 609 VEM. The stress intensity factor (SIF) was calculated using the F.E. model described in section 5 and the analysis includes the thermal residual stress contribution and softening effect of the adhesive. A significant reduction of K is shown over the complete temperature range. Results using two layers of 609 are also shown in Fig. 15.

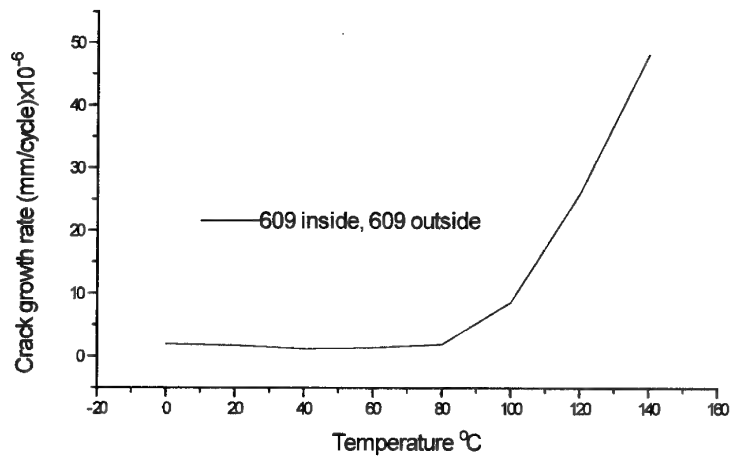
Figure 16 Crack growth rate for highly damped repair.

Fig. 16 shows the crack growth rate for 7075-T6 cracked plate incorporating a patch with two layers of Dyad 609 over the temperature range of interest. In this figure, $equ(6)$ is used to obtain the crack growth rates, with relevant coefficients, including both thermal residual stresses estimated from a closed form solution and adhesive softening. The crack growth rate is relatively low for temperatures of 80°C, beyond this the crack growth increases significantly. In comparison Fig. 17 shows that the crack growth rate for the cracked unrepaired panel compared to the repaired panel is approximately 2700 time greater for temperatures around 40°C. Even at 140°C the crack growth rate of the cracked unrepaired panel is 70 times then that for the repaired panel.

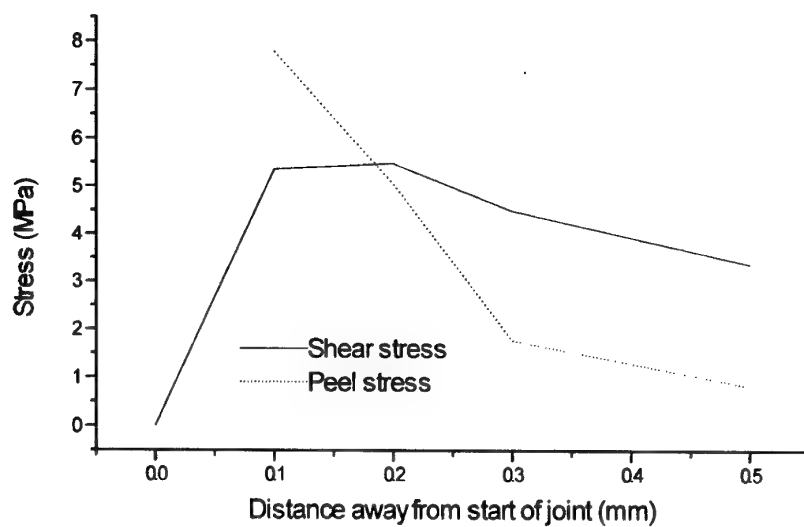
Figure 18. Adhesive stresses bonding boron to aluminium at room temperature.

The adhesive shear and peel stresses in the adhesive layer of the boron repair the are shown in Fig. 18 for the room temperature case. At this particular SPL the stresses are relatively low and no yielding will occur under peel or shear.

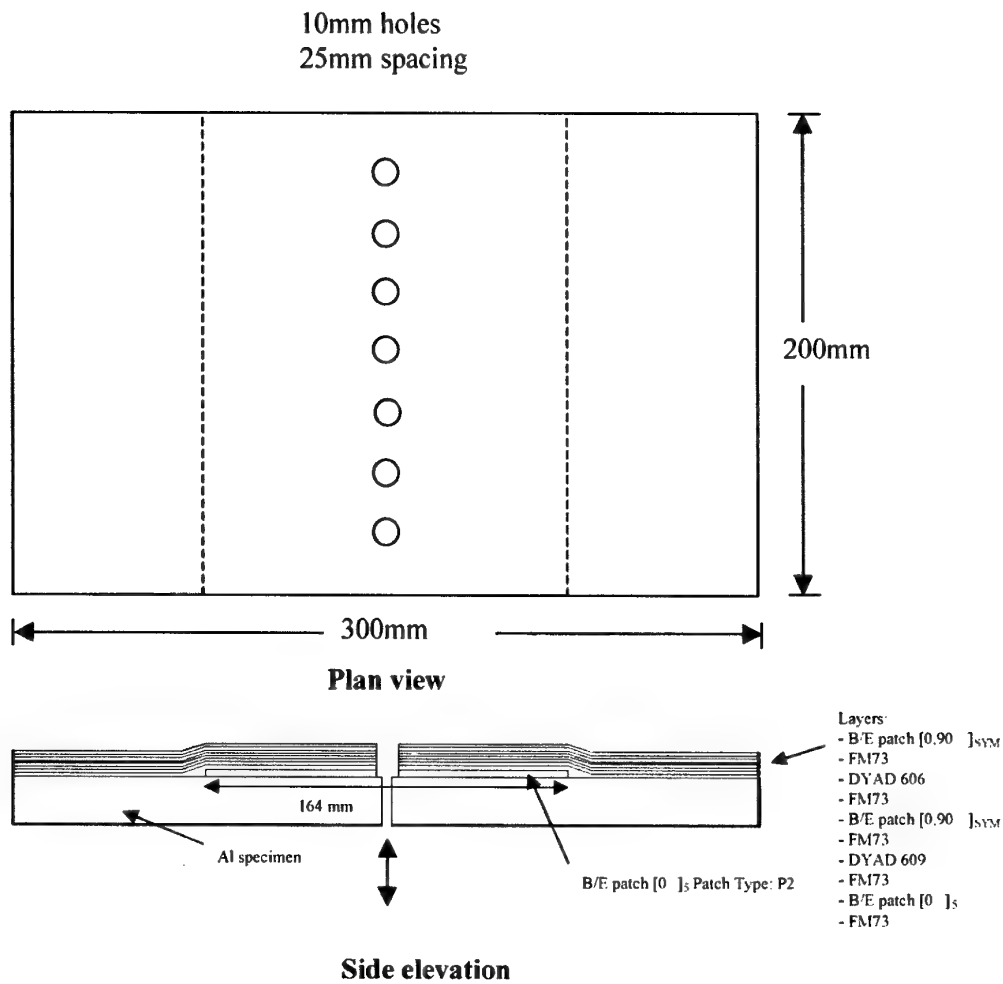
Figure 20. Highly damped repair configuration, from ref(19)

Limited experimental work has been carried out in [19,20,21] in support of the analytical work. While differences exist between the aft fuselage geometry and specimens, similar experimental trends are expected. This work covers testing butterfly specimens which involve the flexing or bending motion shown in Fig. 19, provided by a shaker, in order to simulate the acoustic excitation. The geometry of the specimen is shown in Fig. 20. These specimens consist of bare aluminium specimens with boron/epoxy patches and Dyad 609 and 606 damping layers with $[0,90]_s$ constraining layers. The highly damped repair was applied using room temperature curing adhesive Hysol EA9320. All panels were pre-cracked with a crack length of 25mm. In each case the maximum force applied to the specimen by the shaker was 90N. This forcing level achieved a nominal *rms* strain of about $1000 \mu\epsilon$ ahead of the crack. Comparative results are shown in Fig. 21. In the case of bare aluminium specimens approximately 100,000 cycles were obtained before the resonant frequency of the specimen dropped by 15%. A 15% drop in resonant frequency was used as a criteria to indicate extensive crack growth. For boron/epoxy repairs approximately 1,000,000 cycles were obtained before the resonant frequency of the specimen dropped by 15%. In the case of the highly damped repair the first test with a shaker force of 90N gave no reduction in resonant frequency at 10,000,000 cycles, as shown by the dotted line. A second run was made with the shaker force increased to 180N. The results for this run are shown in Fig. 21. At approximately 10,000,000 cycles a 15% reduction of resonant frequency has occurred. The highly damped repair tested is slightly different to in that analysed above in section 5 in that the constraining layers of $[0/90]_s$ are used in the experimental test rather than the $[0/90]$ plies in the aft fuselage F.E. model. However the experimental results indicate that highly damped repairs are very effective in reducing the crack growth rate.
